Technowrap Splashzone - 24" Oil Import Line

Overview

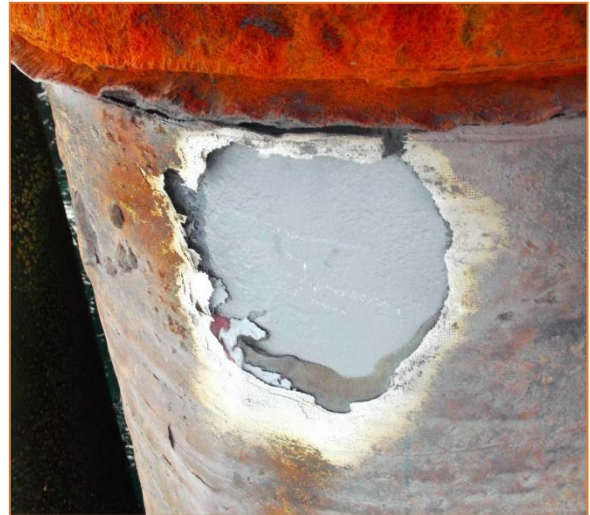
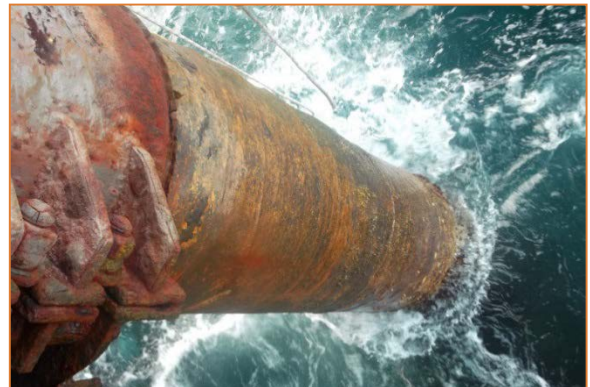
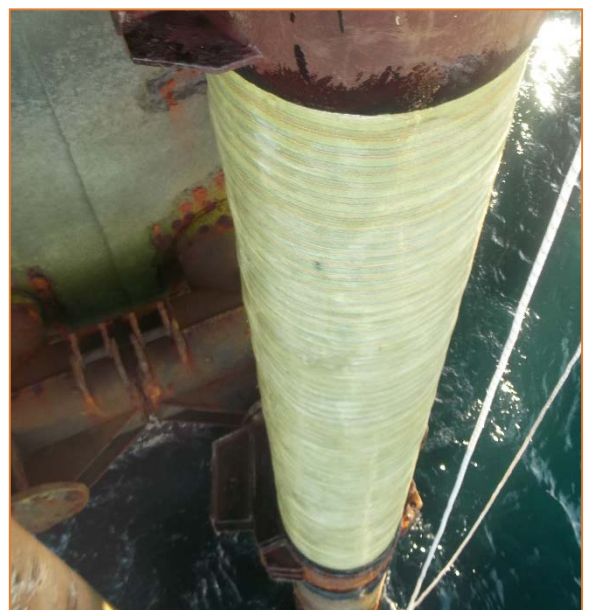
A 24" Oil import line on-board a North Sea platform had an existing repair in place between the 10mtr and 5mtr level between two stabilizing clamps, also in these areas there was external corrosion found from LAT up to the 2.5mtr level.

During blasting, a layer passive fire protection (PFP) was found under an existing repair. The old repair was removed and the layer of PFP remained in tact and Technowrap repair will be applied on top.

8 layers of Technowrap 2K with Splashzone resin were applied over a total length of 7.5meters with 2 layers of Technowrap SRS over the lower 2.5mtr repair to give further structural stability. Walker Technical worked with the asset integrity team who provided surface preparation to ST-3 cleanliness and an average 40µm profile for the required landing areas as per the engineered design calculations.

Following numerous unavoidable delays, the repair was completed guaranteeing the oil import line with an extended life for 20 years. The platform OIE commended the team for their safe and efficient execution.
